An Evaluation of Various Types of Permanent Pallets

By Joseph P. Anthony, Jr. and Robert C. Mongelli¹ Agricultural Marketing Specialists This report evaluates the potential of various permanent 48- by 40-inch pallets for use in unitized systems for handling fresh fruits, vegetables, and frozen foods. These pallets were constructed from a number of materials, such as wood, plastic, and aluminum.

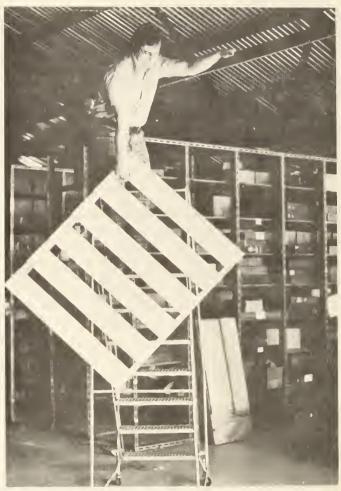
After recovery from the food industry systems, all of the "aged" pallets were then put through a series of eight random corner drops (fig. 2) 4 feet onto a concrete slab. The effects of the drops were observed and recorded.

Figure 2.—Pallets were dropped on a corner from a height of 4 feet, and damage observed and recorded.

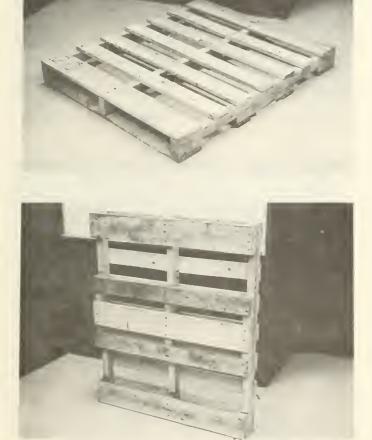
Figure 5.—Pallet A, hardwood standard: A, top view and B, bottom view.

This 48- by 40- by 5-3/16-inch pallet was constructed of hardwood (fig. 5 A and B). Seven deck boards were nailed to three notched runners and five bottom boards were nailed with the notches free to provide four-way handling capabilities. These pallets weighed an average of 61 pounds. This was a dry weight, but once the pallets were exposed to the moisture-laden environment present in the food industry, weights in excess of 80 pounds were quite common.

The wooden pallets that were entered into the aging process were never recovered, and although they are still in use, are lost in the cooperator's system. Using "unaged" pallets, corner drop testing produced no visible damage. The rack storage test produced an average pallet deflection of 0.3125-inch upon loading with 2.000 pounds, 0.3125-inch after 24 hours, and 0.0625-inch after unloading. The floorloading tests using 2,200 pounds revealed no measurable deck deflection at any of the three measurement intervals (upon loading, after 72 hours, and after unloading). Costs for wooden pallets vary, but at the time of this study, were about \$7.50 in truckload quantities of more than 400 pallets.

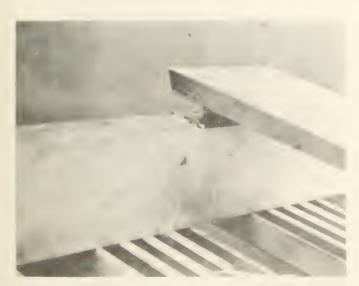
Figure 22.—Broken weld where center slot was attached to runner.

Upon recovery after the aging procedure the pallets showed no signs of damage other than a broken weld where the center bottom slat was attached to the runner (fig. 22). The drop test produced damaged corners (fig. 23), like the other aluminum pallets. These bent corners could cause carton damage. The rack storage test resulted in a pallet deflection of 0.2813-inch upon loading, 0.3488-inch after 24 hours, and 0.1250-inch after unloading. The floorloaded testing yielded a deck deflection of 0.2813-inch after loading, 0.2813-inch after 72 hours, and 0.1250-inch after unloading. While this pallet was experimental, it was similar to a pallet already marketed, and should have an estimated market value of about \$120.
